AFRPL-TR-70-43

**LONG-TERM STORABILITY
OF
PROPELLANT TANKAGE AND COMPONENTS
INTERIM REPORT #1**

R. B. MEARS, 1st LIEUTENANT, USAF

MAY 1970

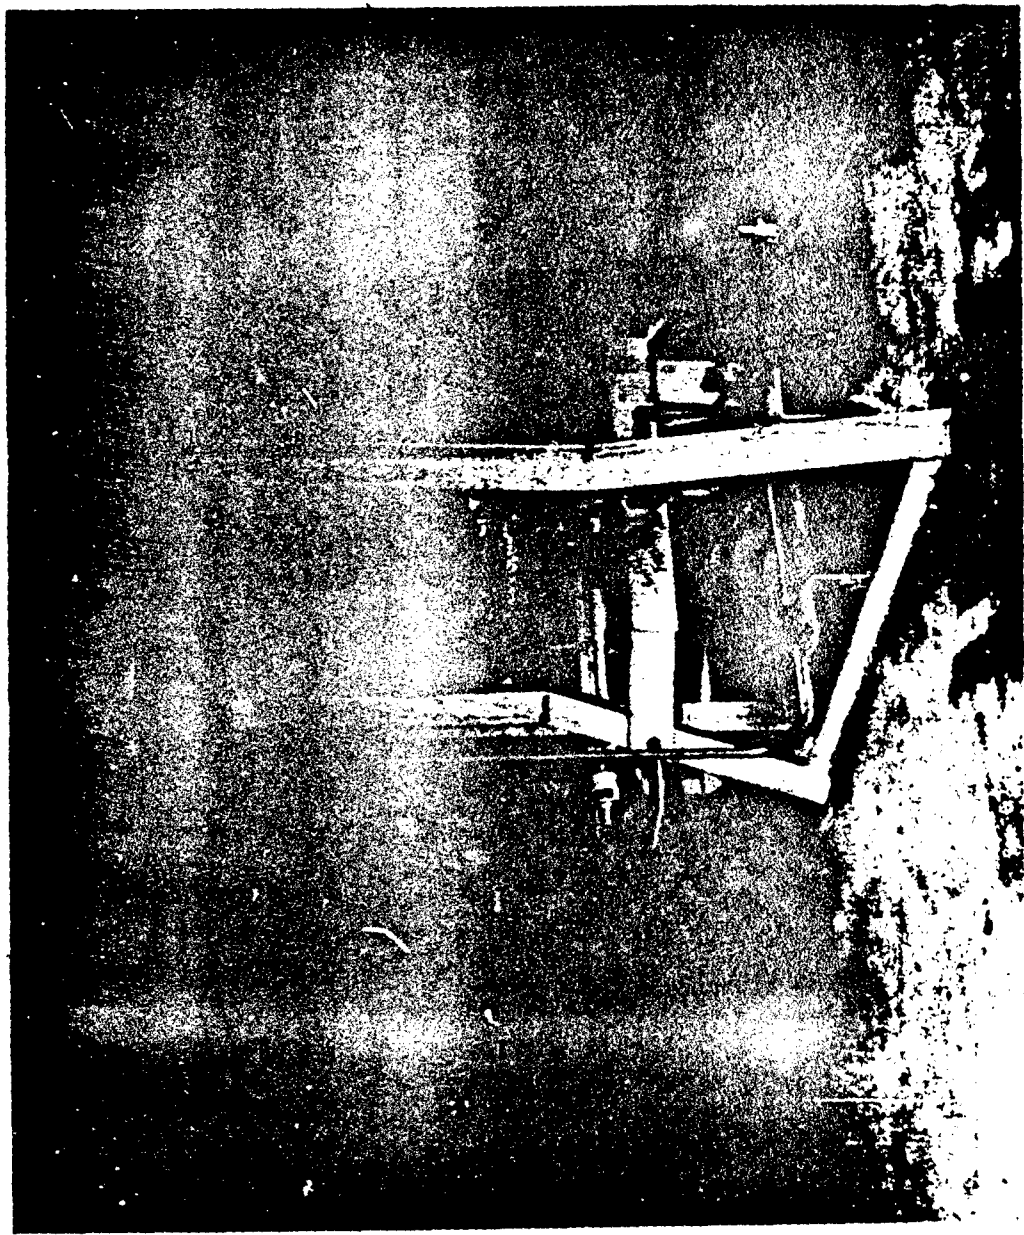
Figure 9. Integrated System With ClF_5 Leak

On 14 August 1969 twelve Phase II integrated systems were loaded with ClF_5 . Approximately two weeks later the environment in the oxidizer storage facility was maintained at 85°F and 85 percent relative humidity. During the afternoon of Friday, 12 September, the storage facility was inspected and no systems were found to be leaking. On the morning of Sunday, 14 September, the facility was again inspected and a very large concentration of ClF_5 vapors was found in the facility. After a thorough inspection it was determined that at least two tanks were leaking ClF_5 , (one Group I 301 cryogenically stretch-formed AISI 301 stainless steel container, and one Group III integrated system with an AM350 steel tank). (Figures 8 & 9) (Appendix II). Numerous other tanks and systems were detanked because of corrosion damage to their external surfaces. The surfaces were cleaned and the tanks helium leak checked, and all tanks were or will be returned to test, since no leaks were found. The original leak was located in an aluminum tubing weld of a system containing ClF_5 . The large concentration of HF (the product of ClF_5 hydrolysis) vapors resulting from the leaks also damaged the building's conditioning system which has been rebuilt.

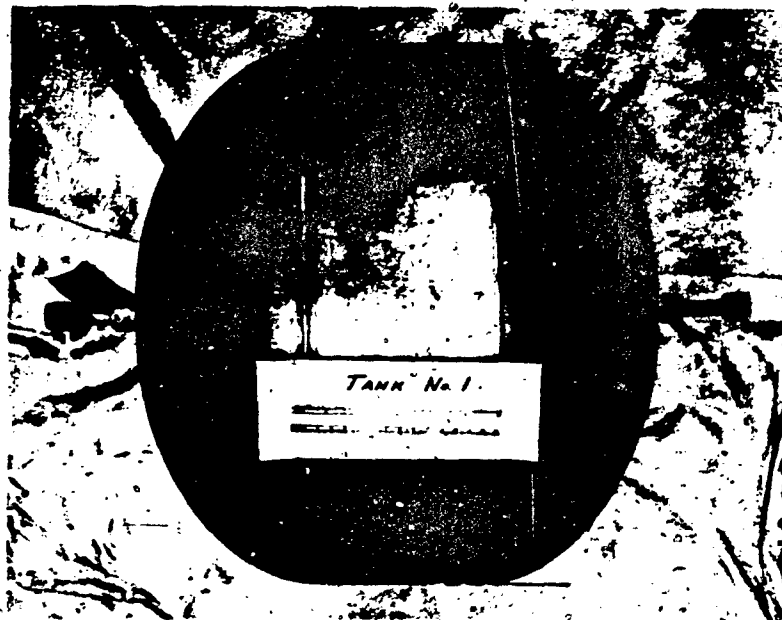
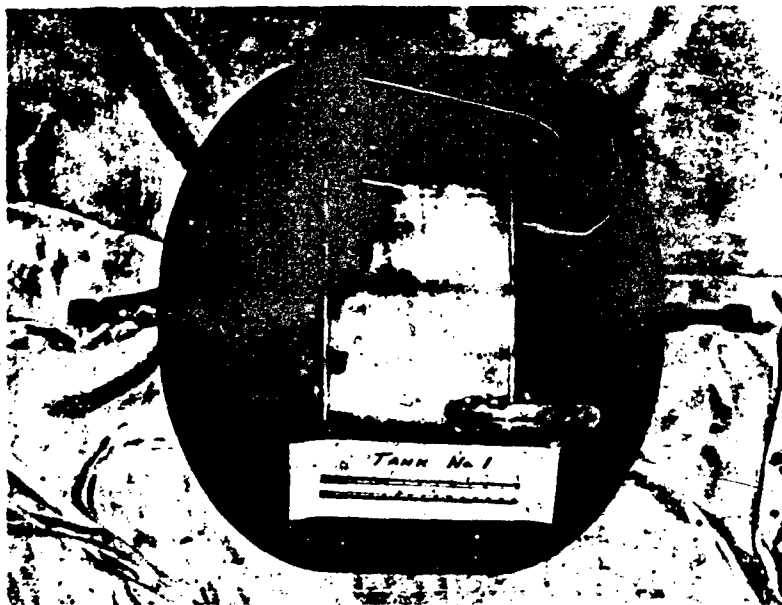
Figure 1. Side Views of Tank No. 1. 0.2X

1. Macroexamination - Two small cracks were visible on the external surface of the tank. The cracks were in the heat affected zone (HAZ) of a dome segment-to-fitting weld. Except for these cracks the overall appearance of the tank was good, Figure 1.

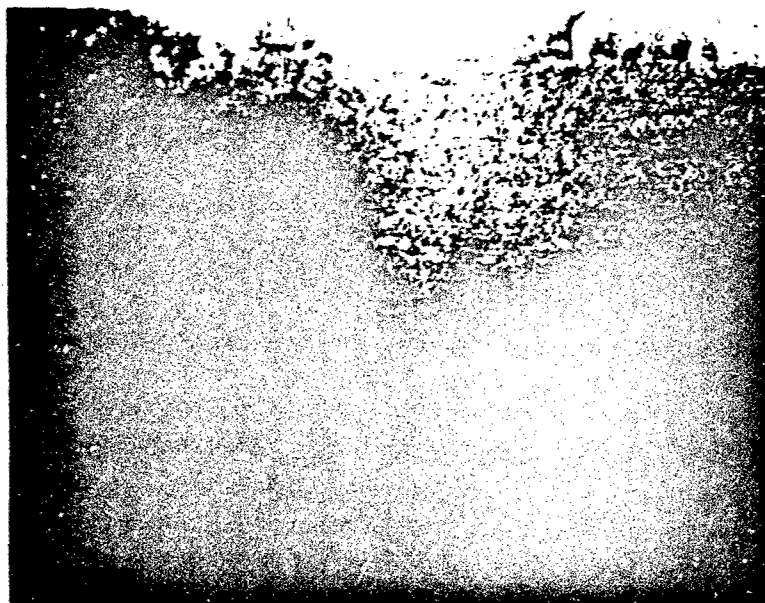
4. **Metallographic Examination** - The areas showing cracks in the X-rays were visibly inspected and numerous small cracks were found in the internal surface of the tank, Figures 4, 5, and 6. Microsections were taken through several of the cracks. As shown in Figures 7, 8, and 9, the cracks were typical of N_2O_4 induced stress corrosion.
5. **Electron Microscopy** - Electron fractography of the fracture surfaces was not possible since the fractures were too small to replicate.
6. **Chemical Analysis** - Although the chemical analysis of the Ti-5Al-2.5 Sn was required to be the extra low interstitial grade (ELI), the analysis of the failed tank showed the material was more closely the normal interstitial grade. This analysis, however, would not result in more stress corrosion occurring than in the ELI grade.

Figure 6. Internal Stress Corrosion Crack
in Bottom of Tank No. 1 ($\approx 20X$)

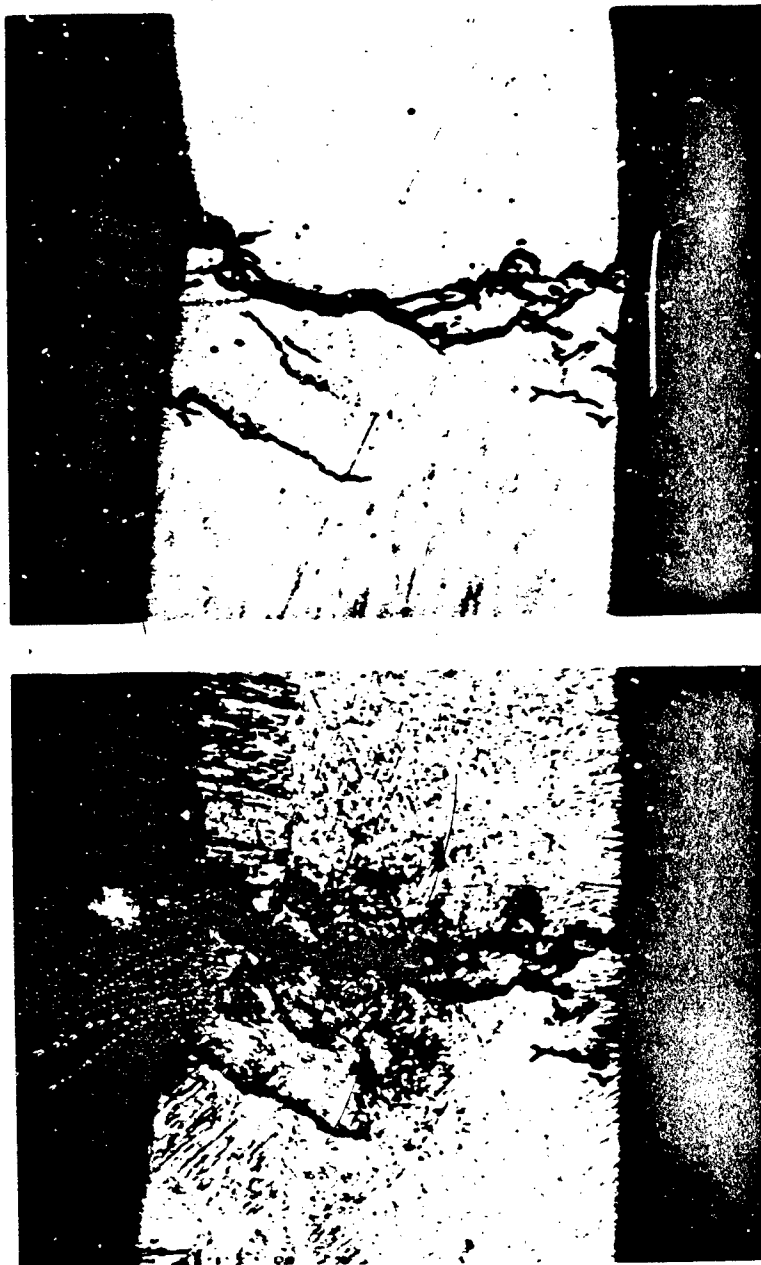
Figure 7. Microsection of Stress-Corrosion Crack in Bottom of Tank (150X)

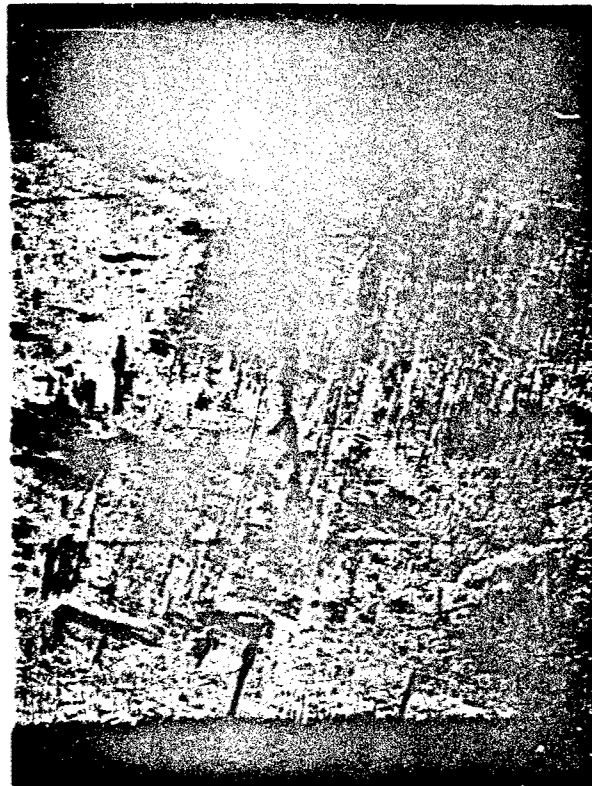
Figure 8. Microsection of Stress-Corrosion Crack
in Bottom of Tank No. 1 (150X)

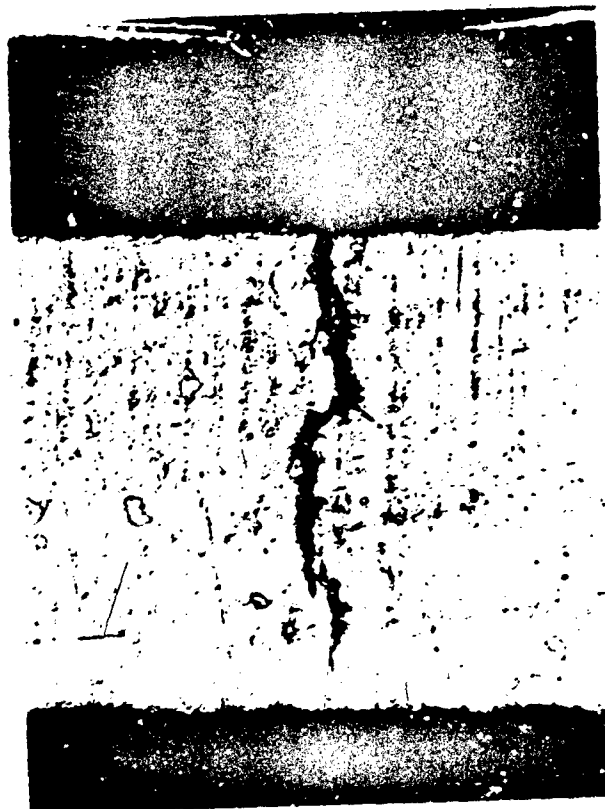
Figure 9. Microsection of Stress-Corrosion Crack
in Top of Tank No. 1 (150X)

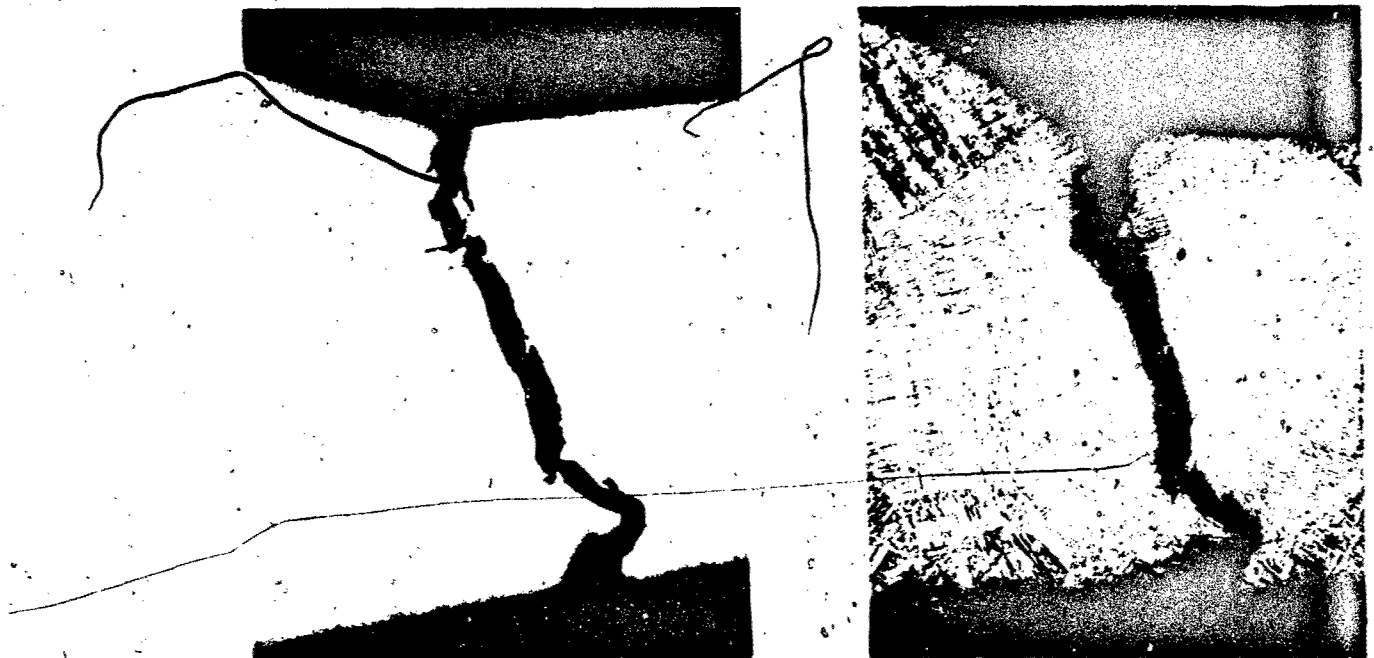
1. The origin of failure of small tank AFRPL S/N 2 was a hot-short crack in the fusion zone (weld bead edge) of a repair weld.
2. Insufficient inert gas coverage, in repair welding the tank, resulted in the formation of stabilized alpha on the surface of the titanium in the weld heat affected zone. This created an embrittled surface and an area of stress concentration.

Figure 5. Photomicrographs of Hot-Short Crack in Leak Area
Unetched and Etched (100X)

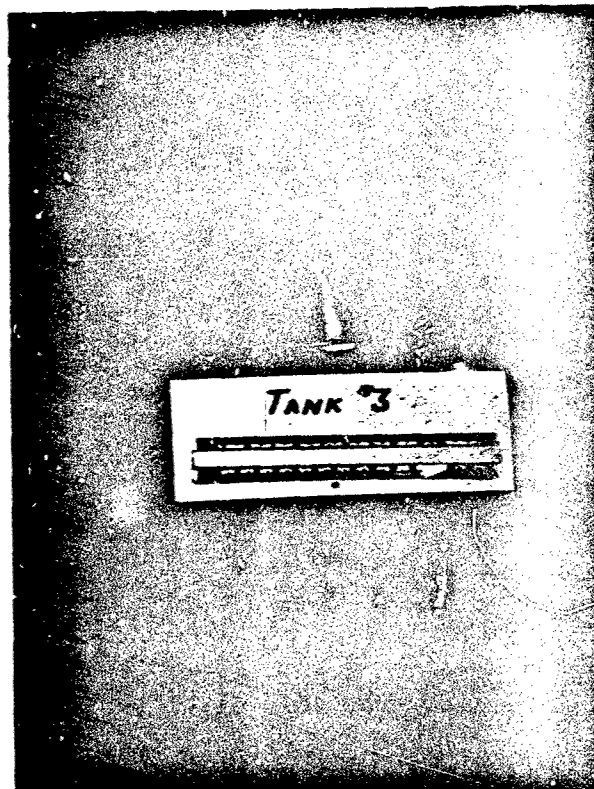
Figure 1. Leak Area of Tank No. 3

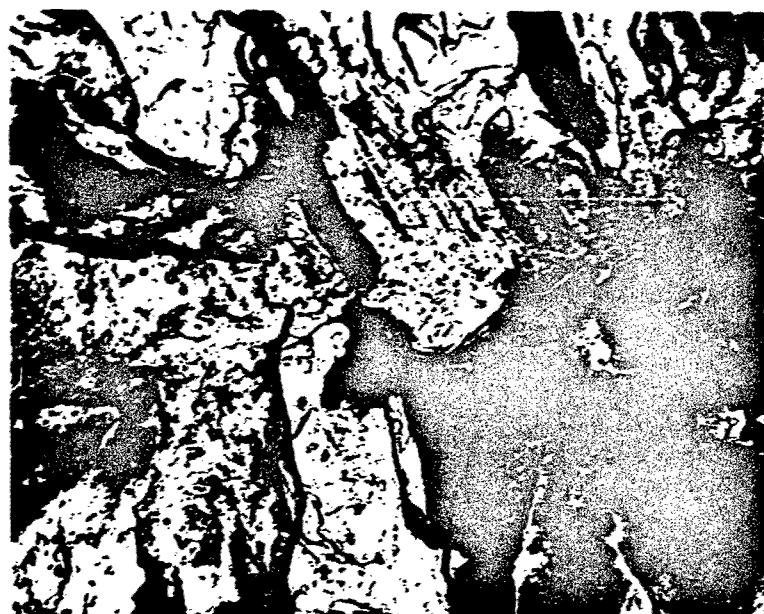
Figure 9. Electronphotomicrograph Showing Evidence of Stress Corrosion (6500X)

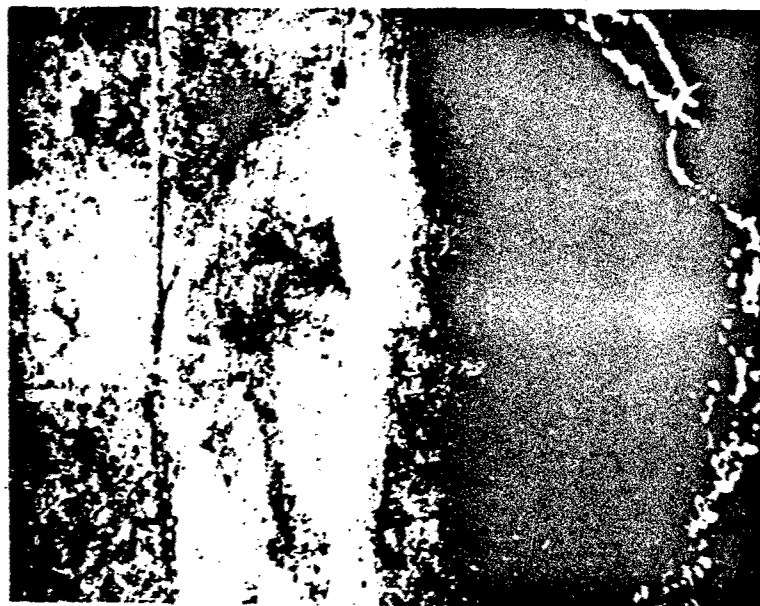
Figure 6. Photomicrograph Showing a Leak in the Bottom of the Failed Tank. 10X

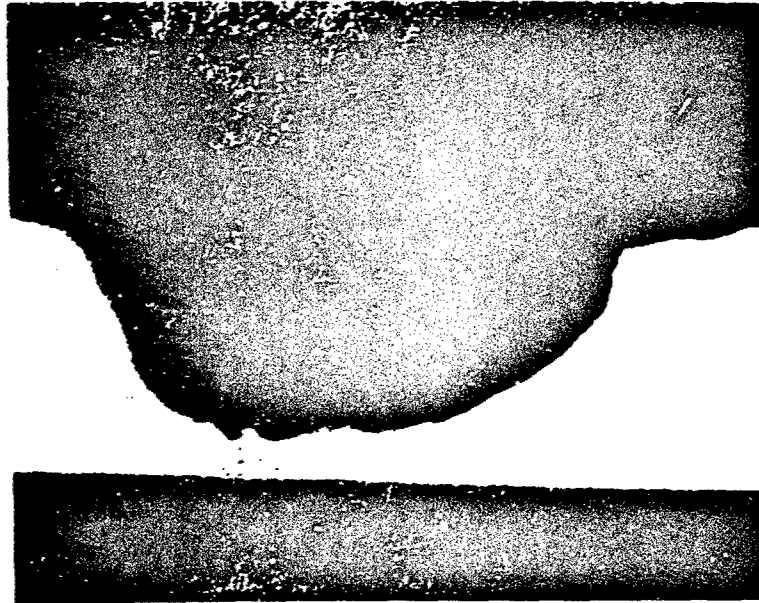
Figure 9A. Photomicrograph Showing a Cross Section of a Pit in the Bottom of the Failed Tank. Unetched 60X

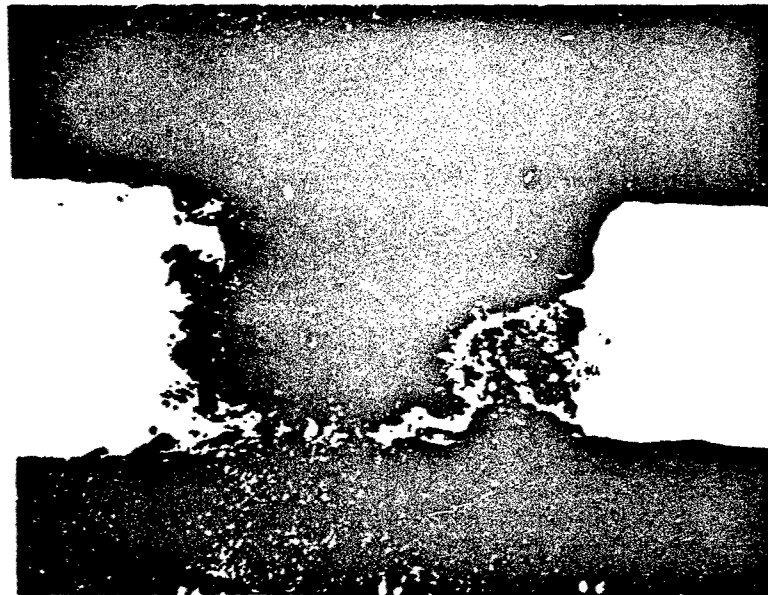
Figure 9B. Photomicrograph Showing Another Cross Section of a Pit in the Bottom of the Failed Tank. Unetched 60X

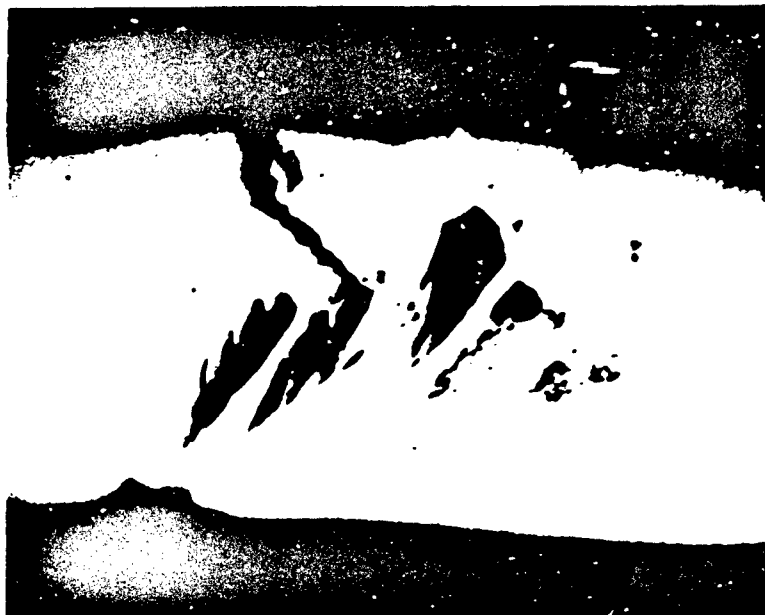
Figure 10. Photomicrograph Showing a Cross Section Through the Hot Short Crack in the Origin of the Failure of Tank Serial Number AF-4
Unetched 60X

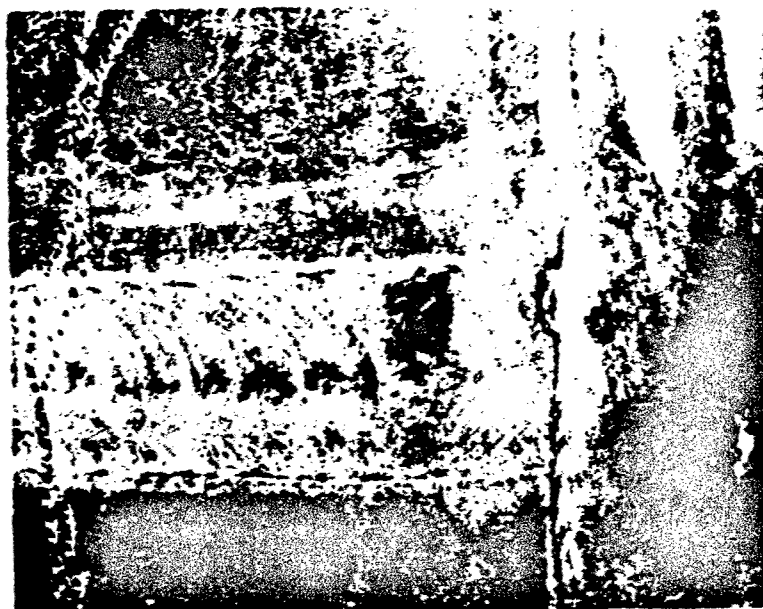
Figure 12. Photomicrograph Showing Pitting Corrosion Near a Weld Cross-Over on the Outside Bottom of the Failed Tank 10X

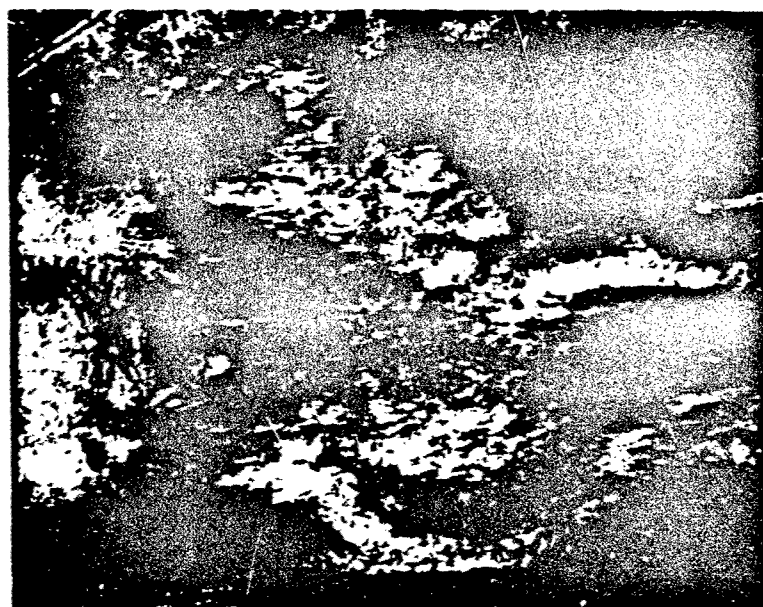
Figure 13. Photomicrograph Showing Pitting Corrosion in a Ground Area of a Weldment on the Outside Bottom of the Failed Tank 10X

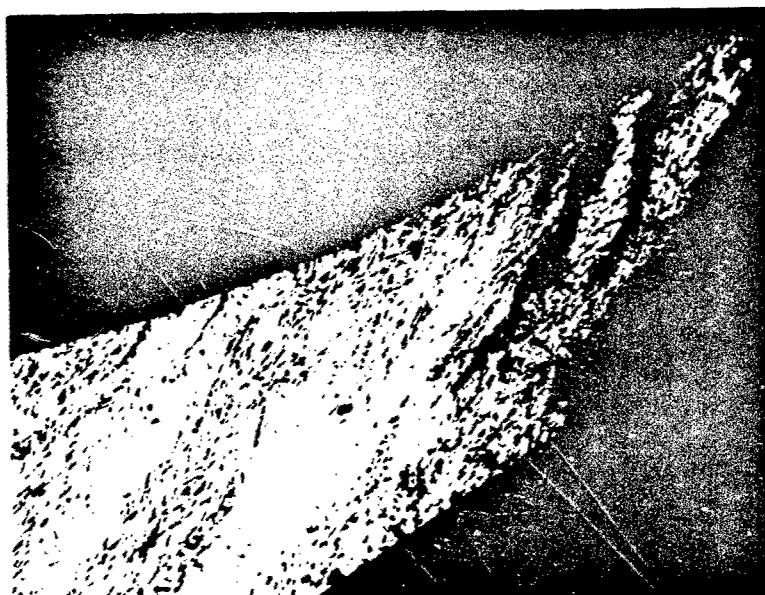
Figure 6. Microsection Through Area Shown in Figure 5. (25X)

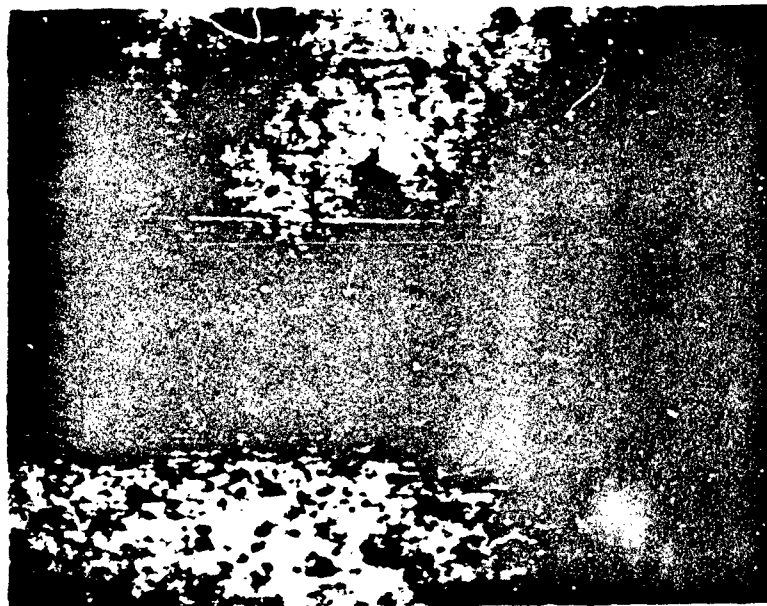
Figure 7. Photomacrograph of Cracks Near Fillet Weld of Tube Assembly (20X)

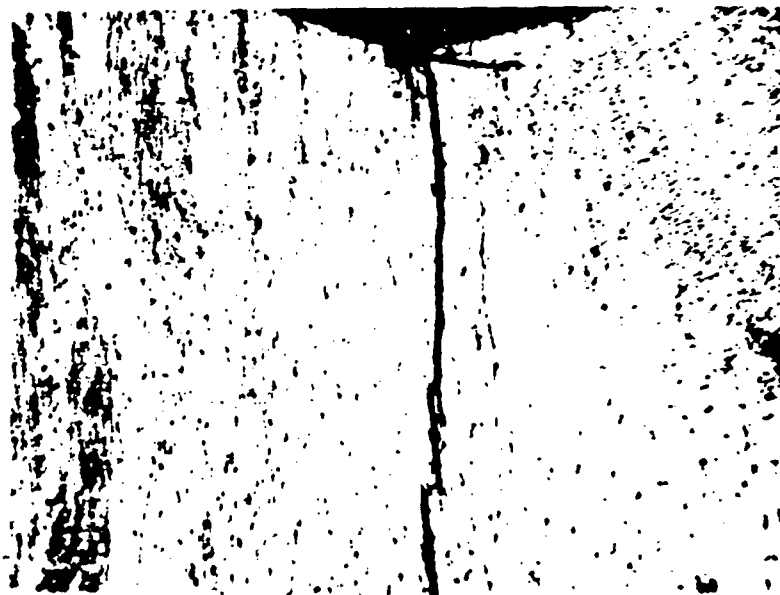
Figure 8. Microsection Through Crack Shown in Figure 7. (50X)

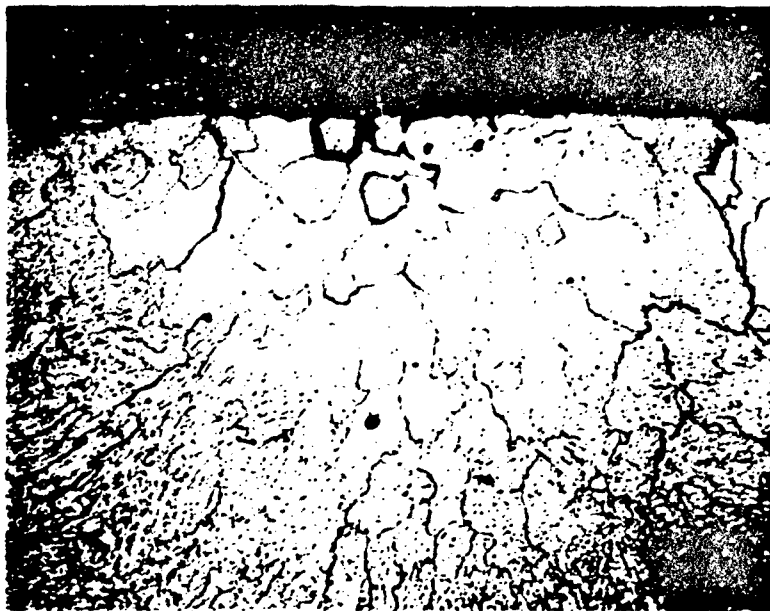
Figure 11. Photomicrograph of Intergranular Corrosion and Stress-Corrosion Cracks on External Surface of Area Shown in Figure 10. (50X)

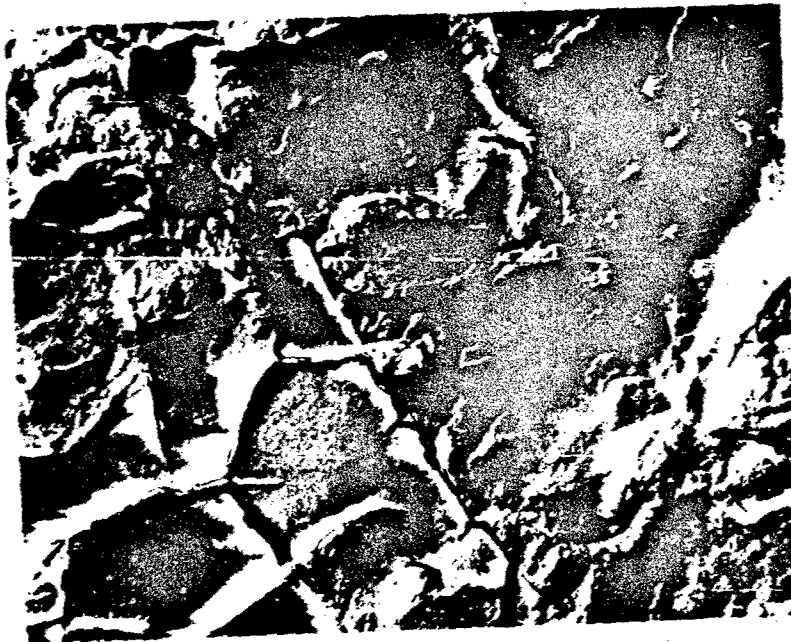
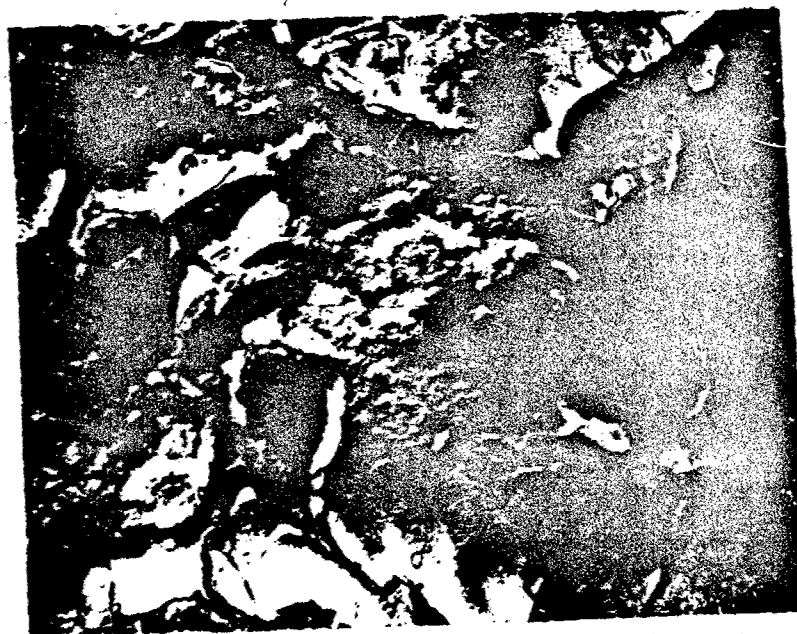
Figure 12. Electron Photomicrographs of Fracture Surface of Outlet Crack. (6500X)

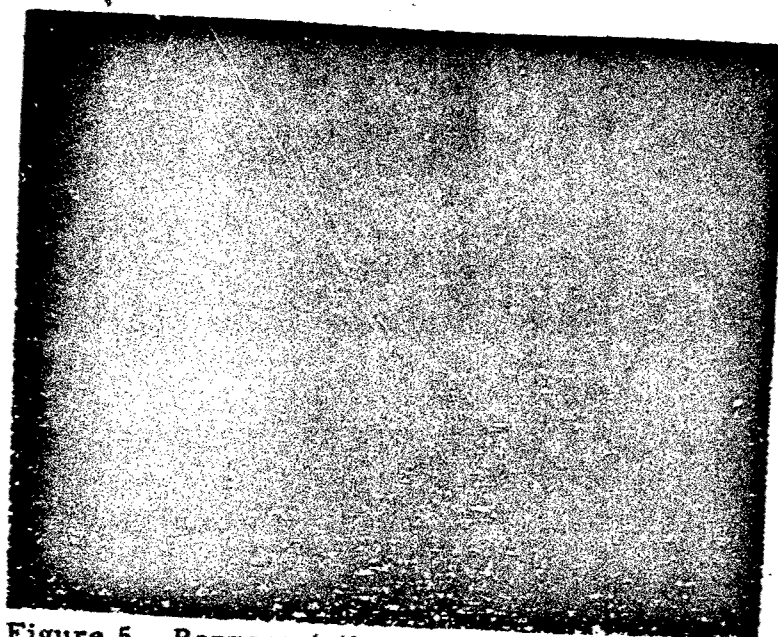
Figure 5. Representative Photomicrograph of
Corrosion Pits in Tank No. 6. 100X

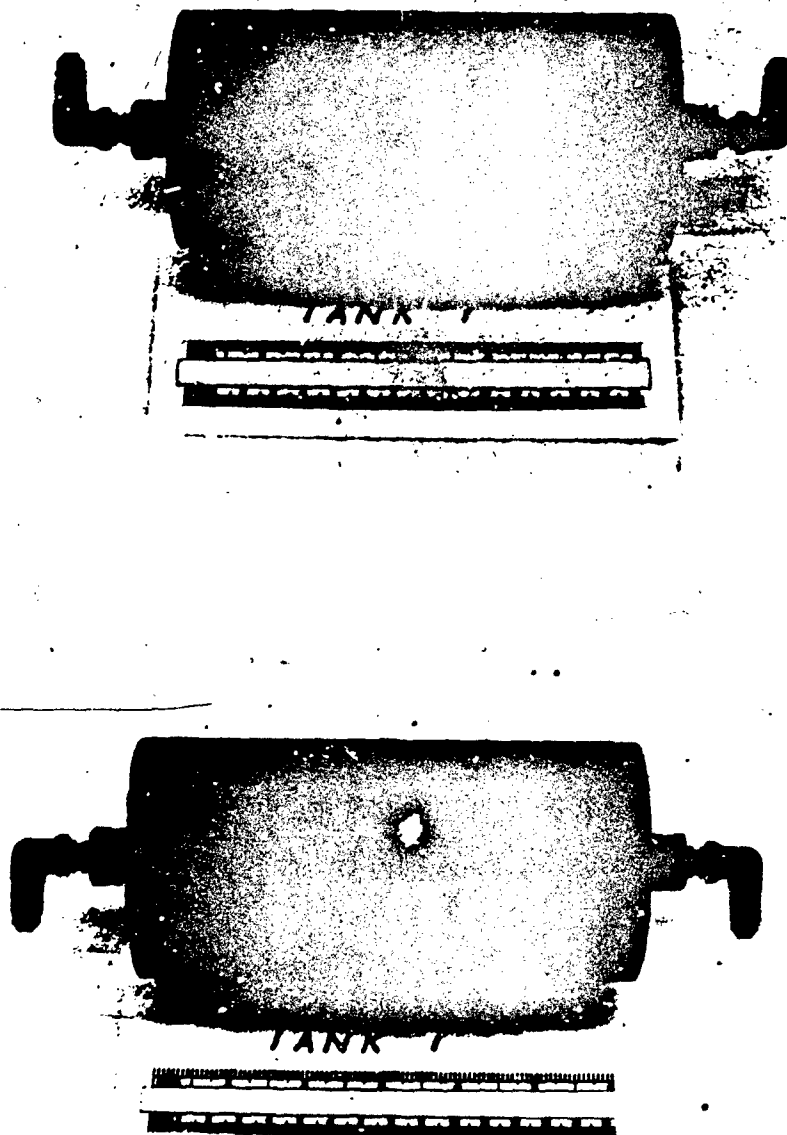
Figure 1. Sideviews of Tank Number 7. 1/2X
Note the Generally Etched Appearance
of the Tank.

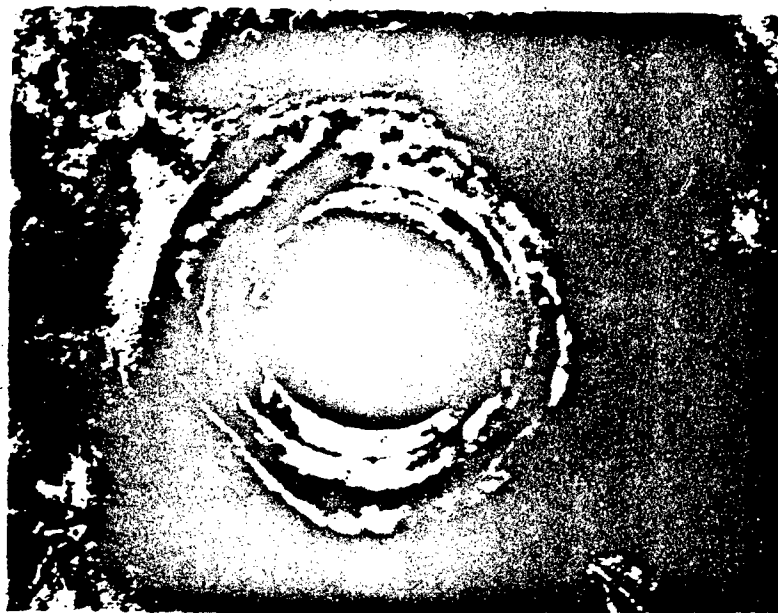
Figure 3. Stress-Corrosion Cracks and Pitting in End Bond Weld of Tank Number 7. 2 1/2X

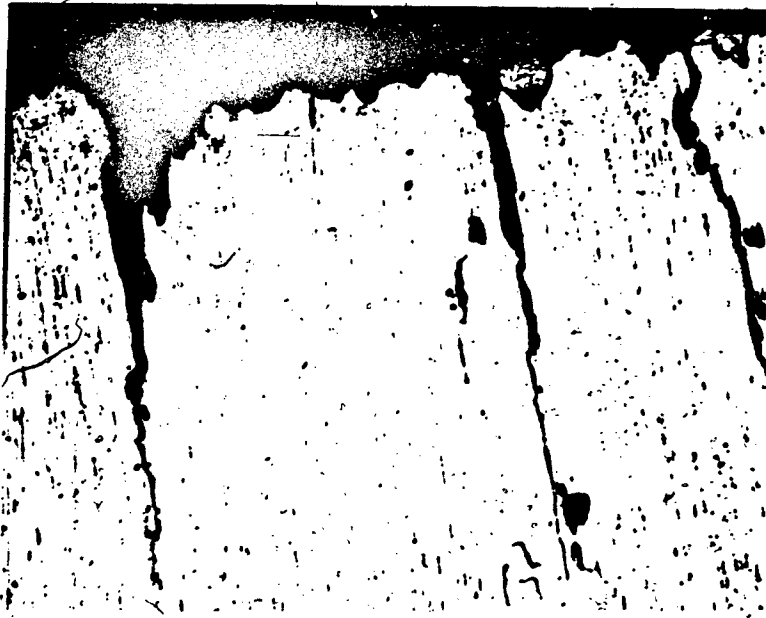
Figure 5. Photomicrograph of Stress-Corrosion Cracks
in HAX (100X)

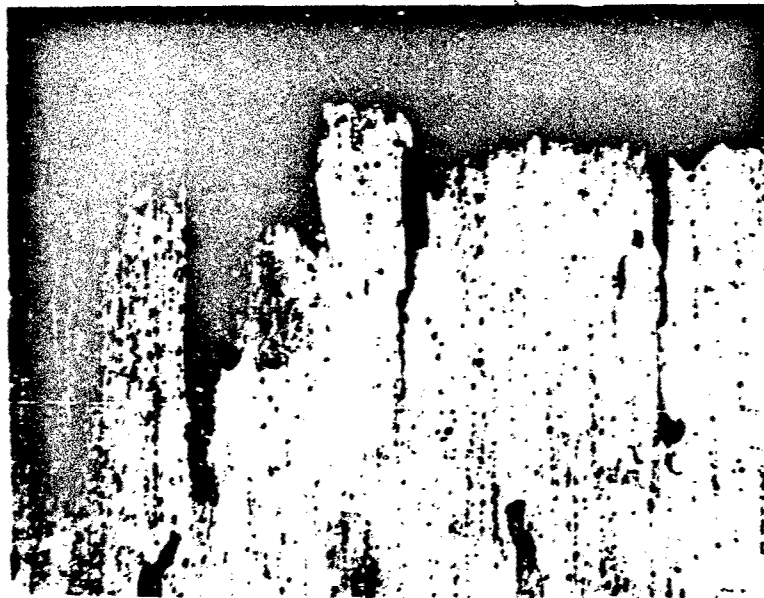
Figure 6. Photomicrograph of Area in Figure 5 in Etched Condition showing End Grain Exposure (75X)

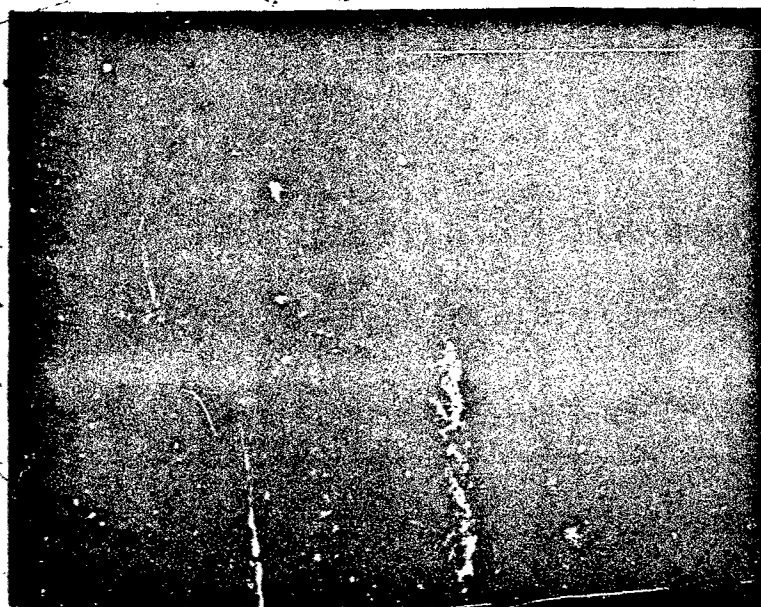
Figure 5. A Photomicrograph Showing the Pitting Corrosion In The Area of The 2.16×10^{-7} atm cc/sec Leak. 10X Magnification

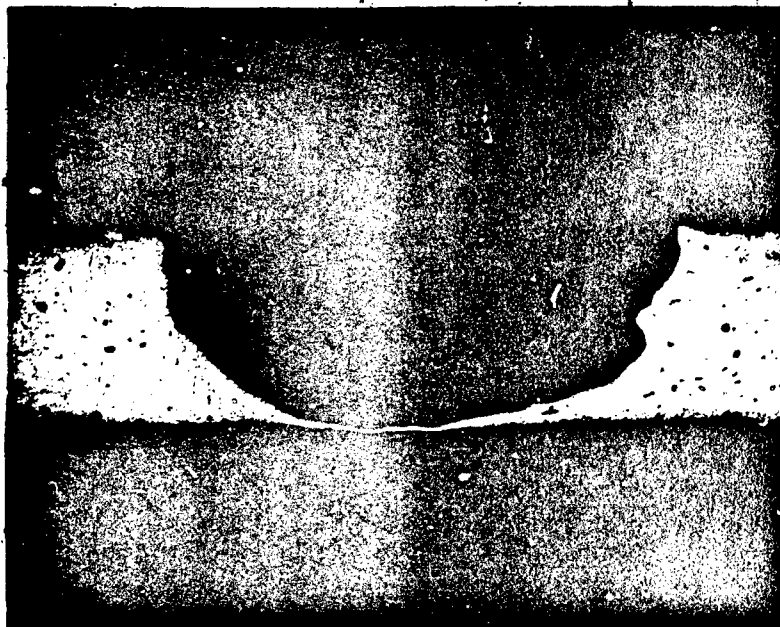
**Figure 6. Photomicrograph Showing The Corrosion Pit
In The "OFF-Scale" Leak. 50X Magnification**

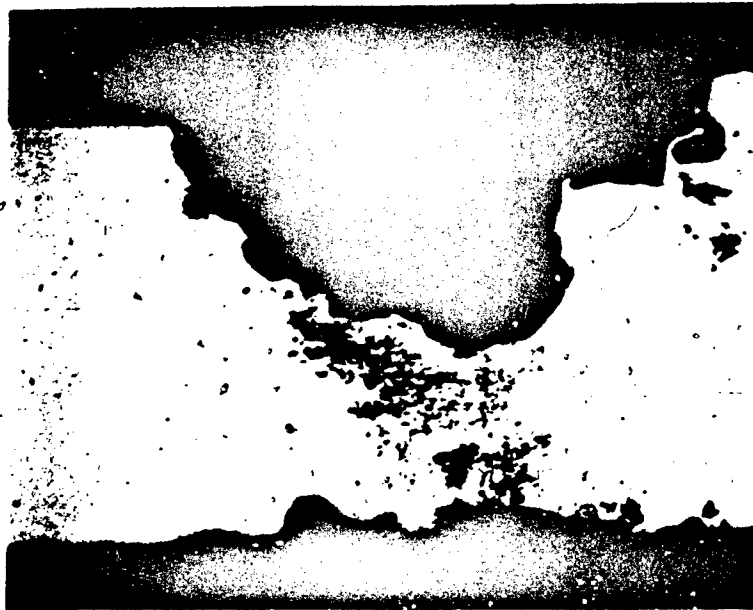
Figure 4. Photomicrograph Showing The micro-structure in a leak area of the AM350 precipitation-hardening stainless steel tank No. 9. 100X

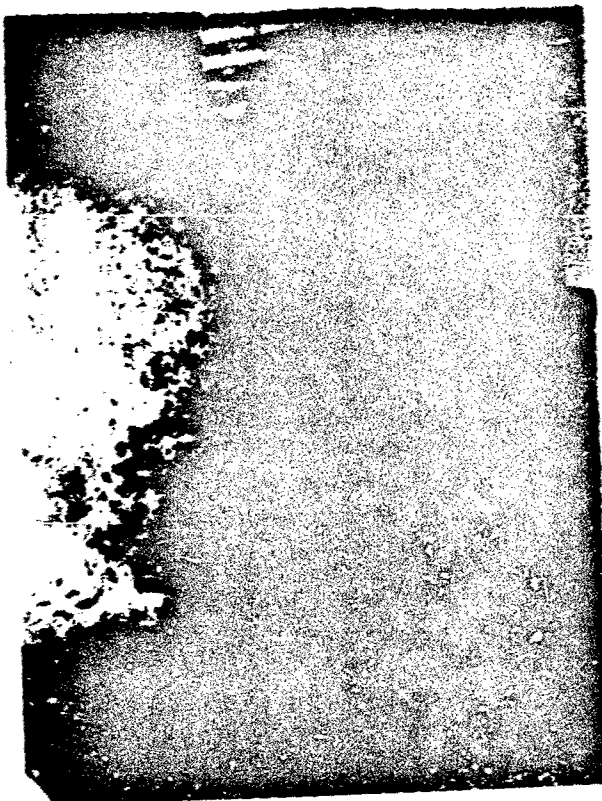
Figure 4. Large corrosion pit in HAX of fitting
of end "B" of Tank No. 10. 3X

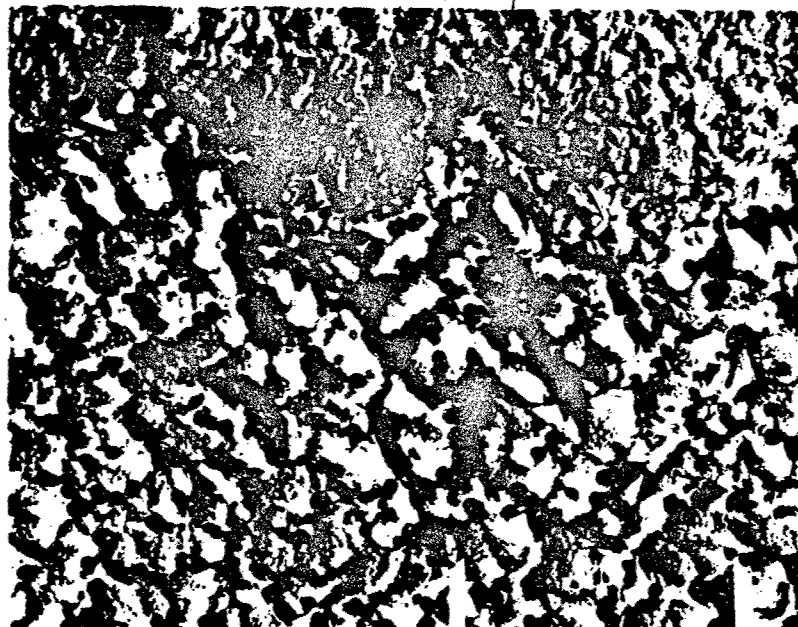
Figure 6. Electron Photomicrograph of Corrosion Failure in Tank No. 10. 7000x

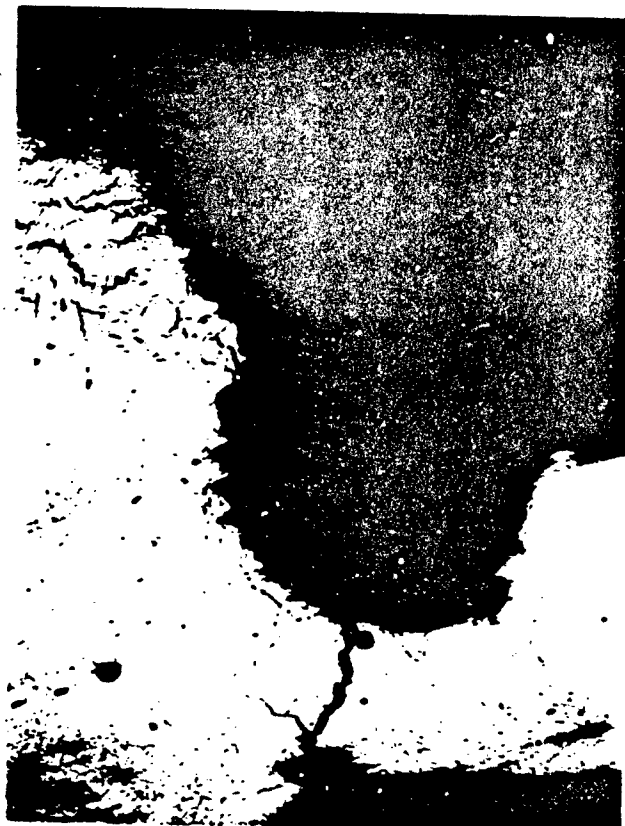
Figure 7. Leak Area in Fitting of Tank No. 10.
75X

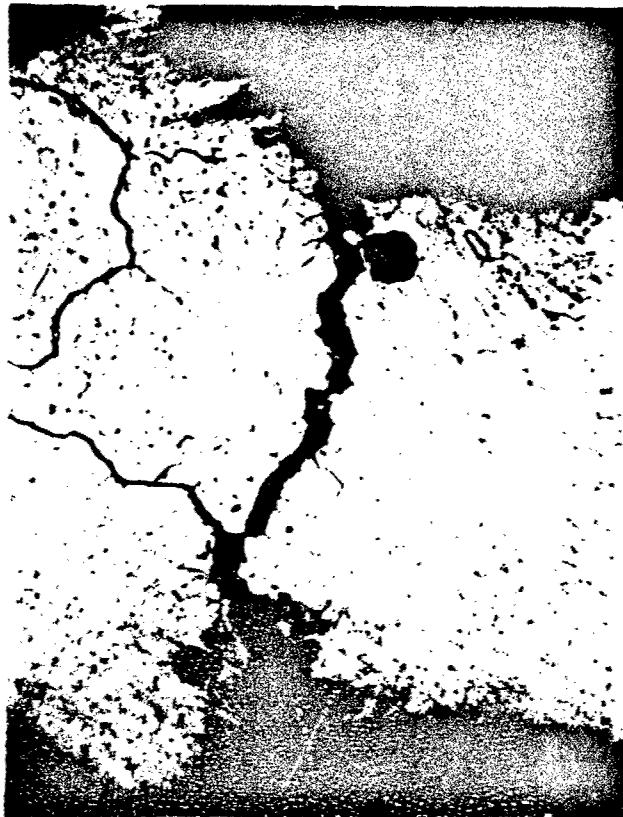
Figure 8. Leak Area Shown in Figure 7
at 200X.

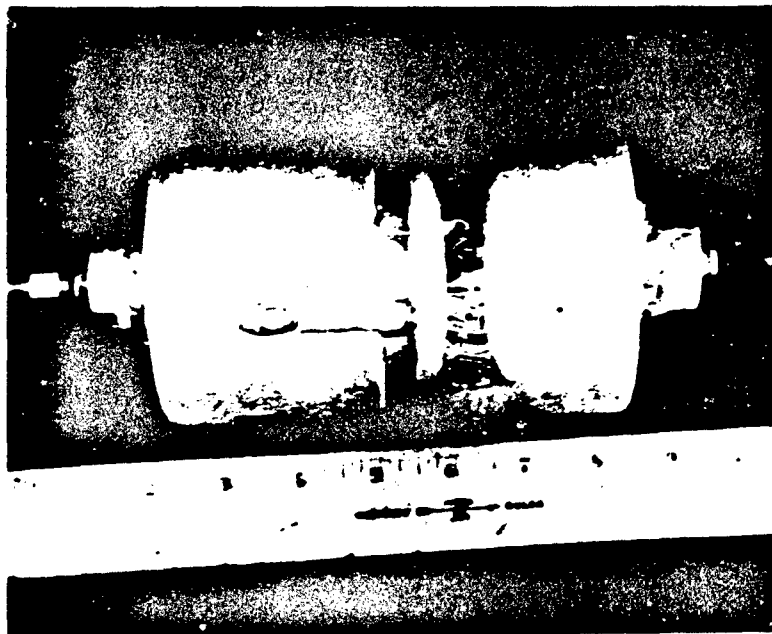
Figure 1. Photomicrograph showing overall sideview of small tank no. 12. Top of tank is shown to the right. 0.6X

9. Corrosion Product Analysis - The corrosion product obtained from the external surfaces of the tank was identified as aluminum fluoride hydroxide hydrate, reference (7). This is the corrosion product that would be likely to form as the result of ClF_5 attack.

As shown previously in tests at Martin Marietta Corporation, weld areas are attacked by acid environments as much as twenty to thirty times faster than parent metal depending on the amount of weld heat applied to the weldments in aluminum alloys. Starts and stops in welds are particularly susceptible. Therefore, if an oxidizer such as ClF_5 or N_2O_4 should leak near weld areas and acids form as a result of hydrolysis of these propellants, the weld zones will start showing severe attack within 48 hours. (Reference 8).

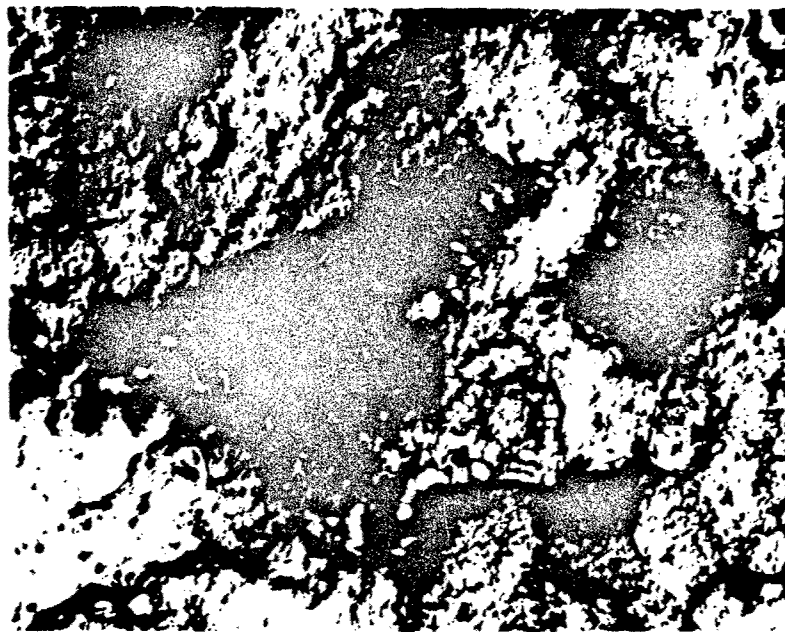
Figure 15. Electron photomicrograph showing representative evidence of intergranular corrosion observed on the surface of the fractures of leak areas 62 x 1 and 32 x 10. 15,000X

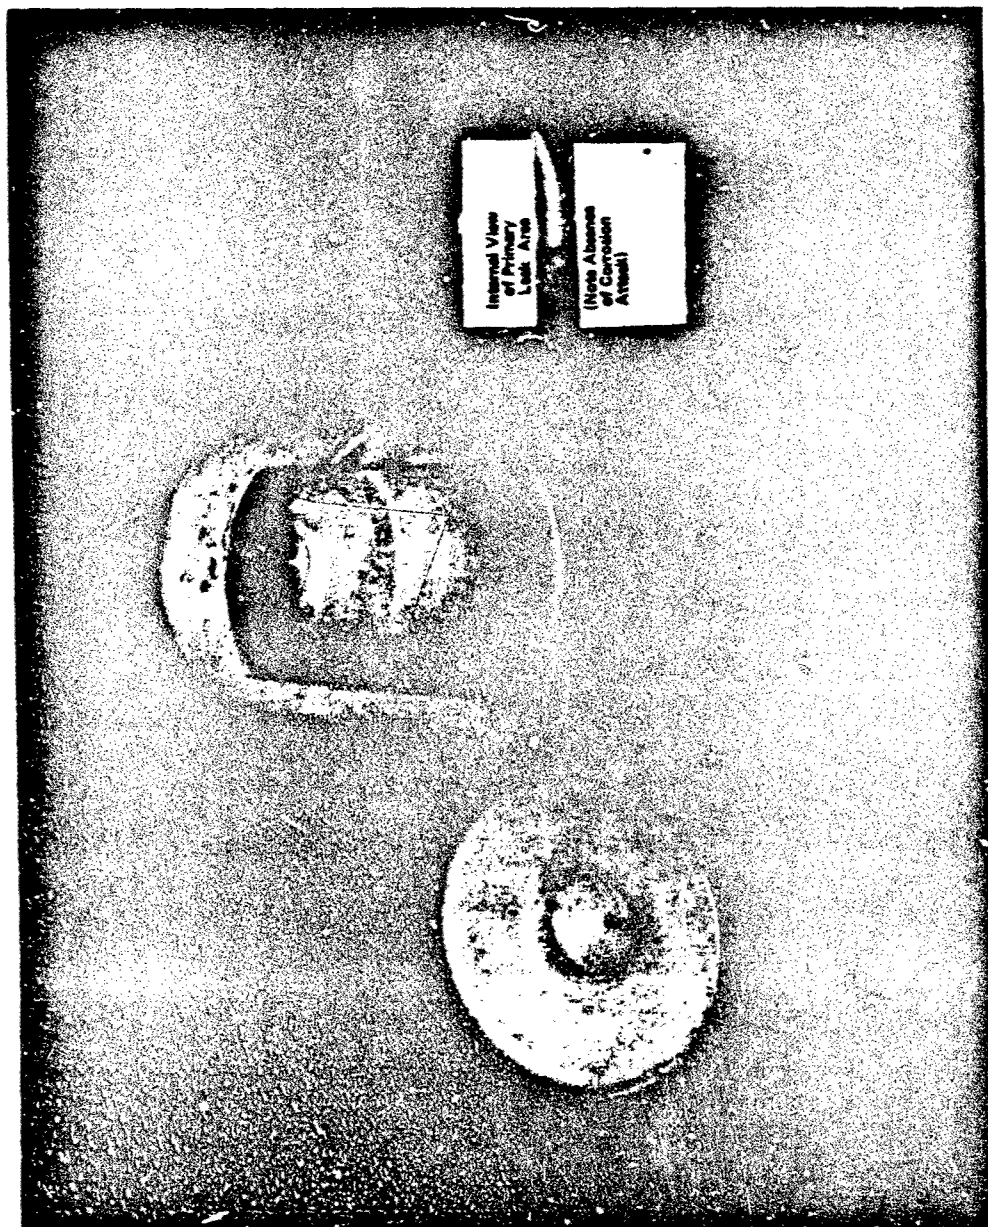
Figure 3. Internal View of Primary Leak Area
(Note Absence of Corrosion Attack)

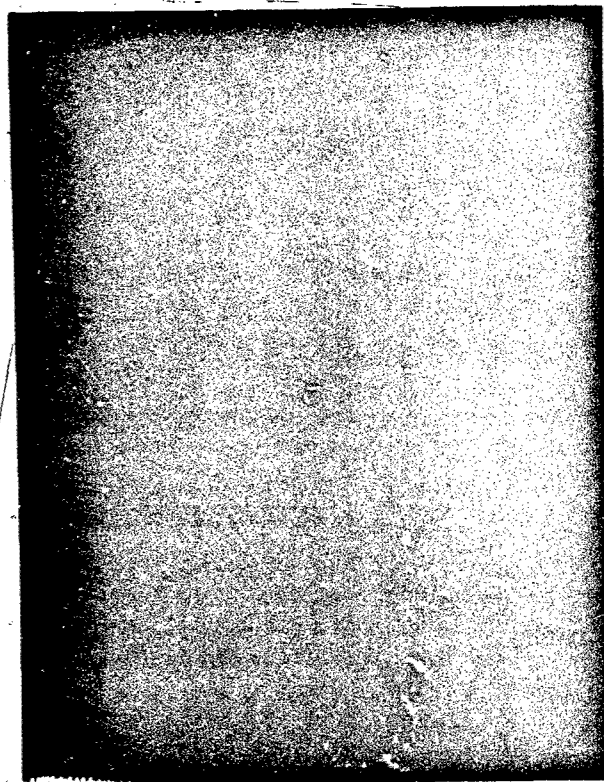
Figure 5. Internal View of Holes in HAZ
of Vertical Weld Bead
